ANNUAL LANDFILL INSPECTION REPORT

**Sunflower Electric Power Corporation
Holcomb Station Unit #1
2440 Holcomb Lane / P.O. Box 430
Holcomb, KS 67851**

January 7, 2021

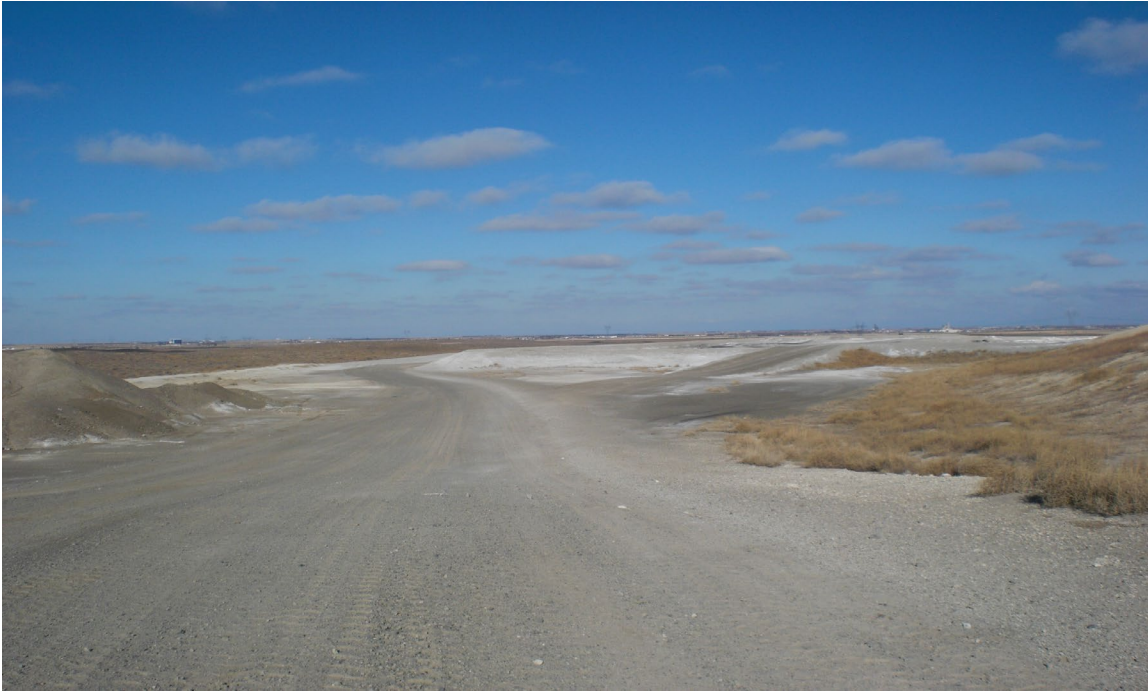
Photo 1: Entrance road to Phase 3A

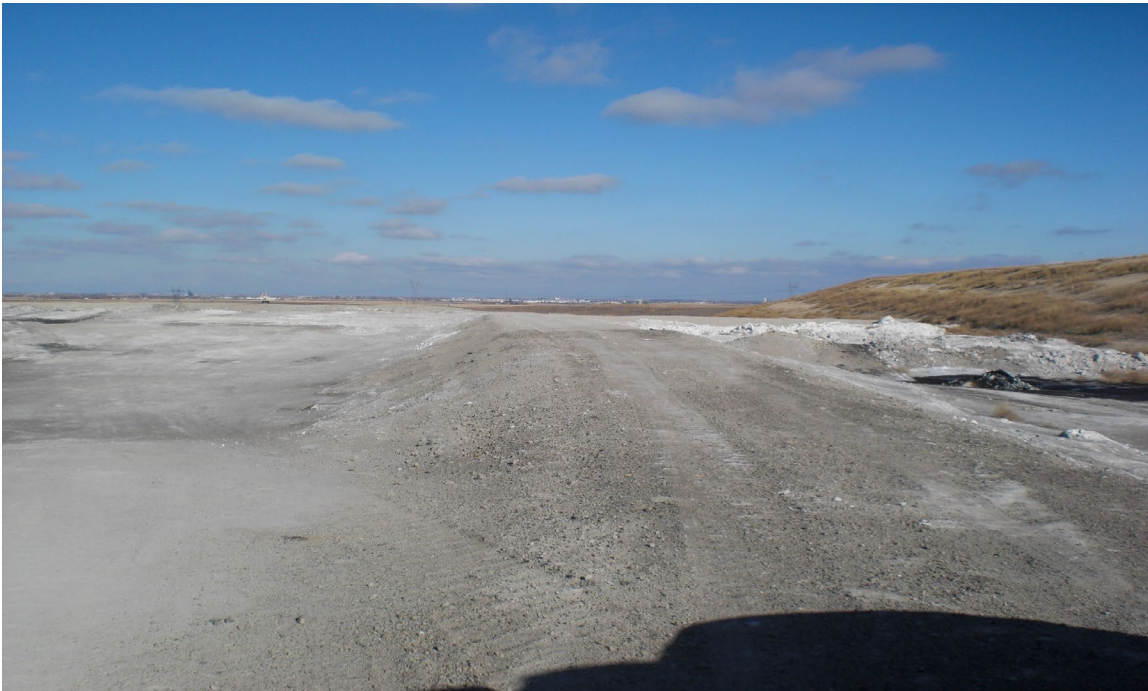
Photo 2: Phase 3A looking east. On top of waste pit.

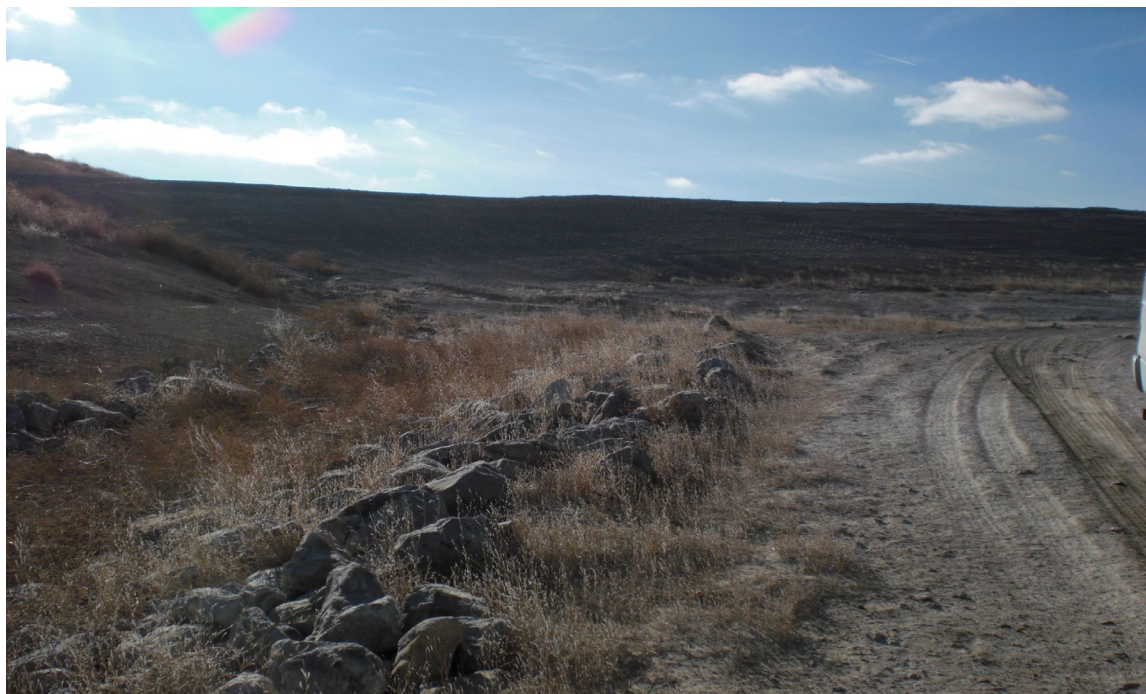
Photo 3: Contact water ditch for Landfill looking west

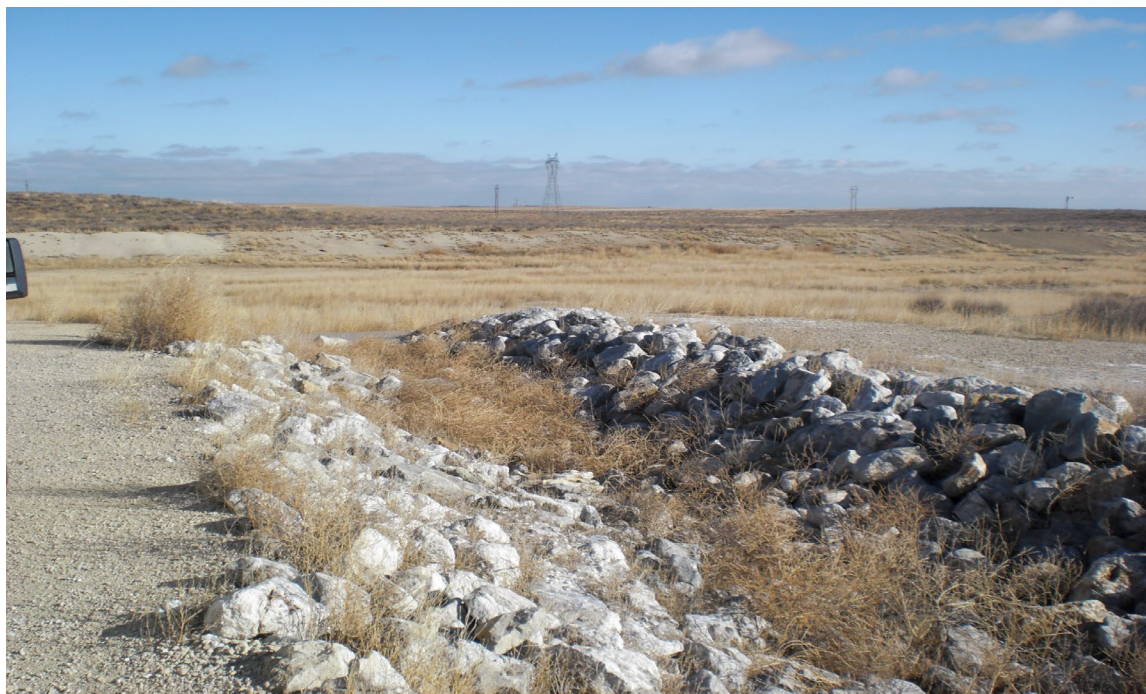
Photo 4: East end of contact water ditch to evaporation basin

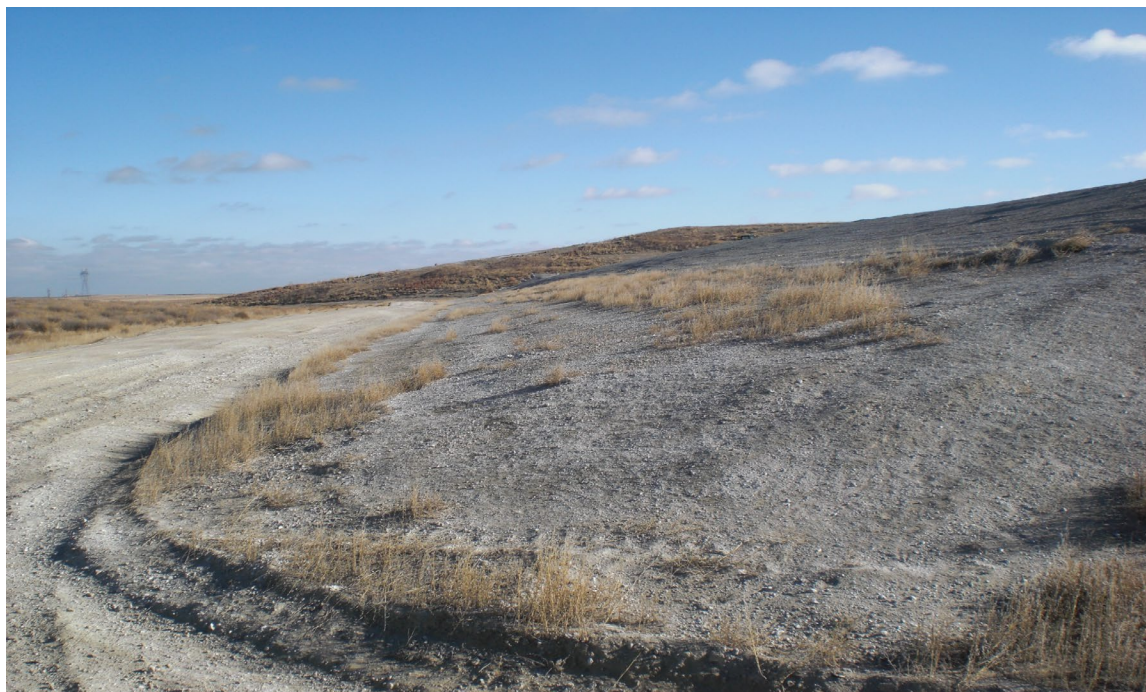
Photo 5: On access road around Phase 3A

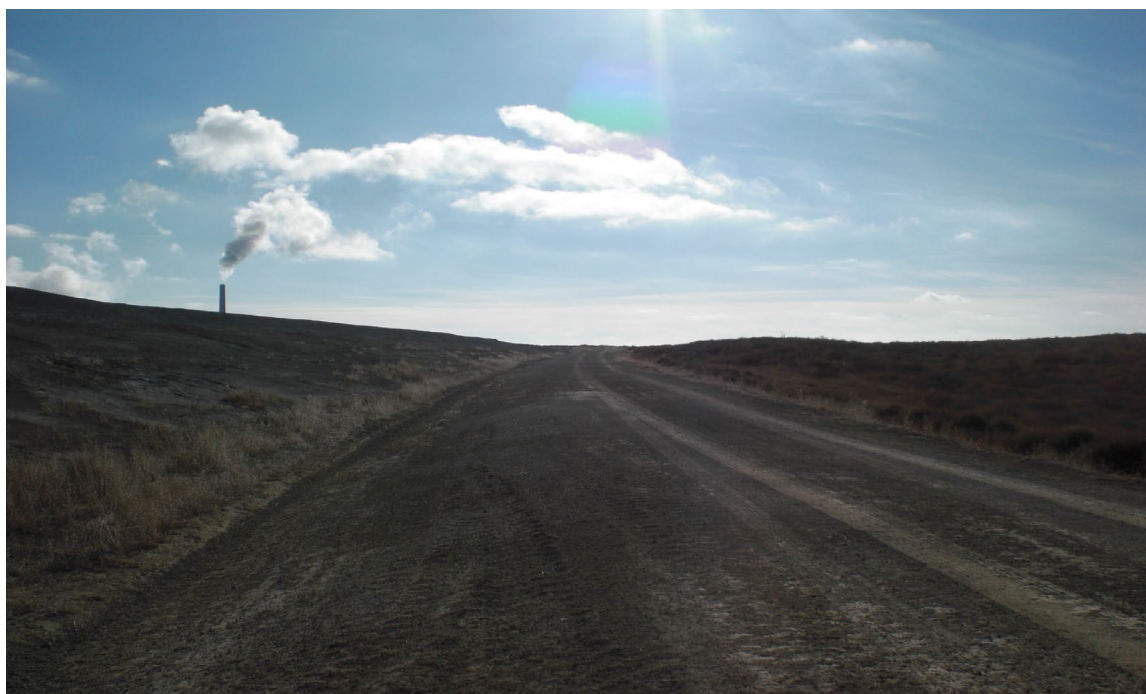
Photo 6: Looking south from access road around Phase 3A
