**SUNFLOWER ELECTRIC
POWER CORPORATION**

ANNUAL LANDFILL INSPECTION REPORT

**Sunflower Electric Power Corporation
Holcomb Station Unit #1
2440 Holcomb Lane / P.O. Box 430
Holcomb, KS 67851**

January 4, 2024

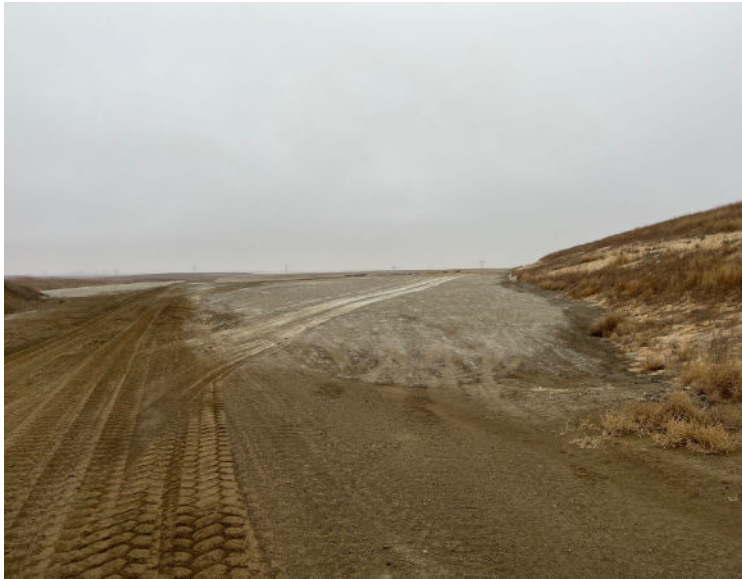
Photo 1: Entrance Road to Phase 3A

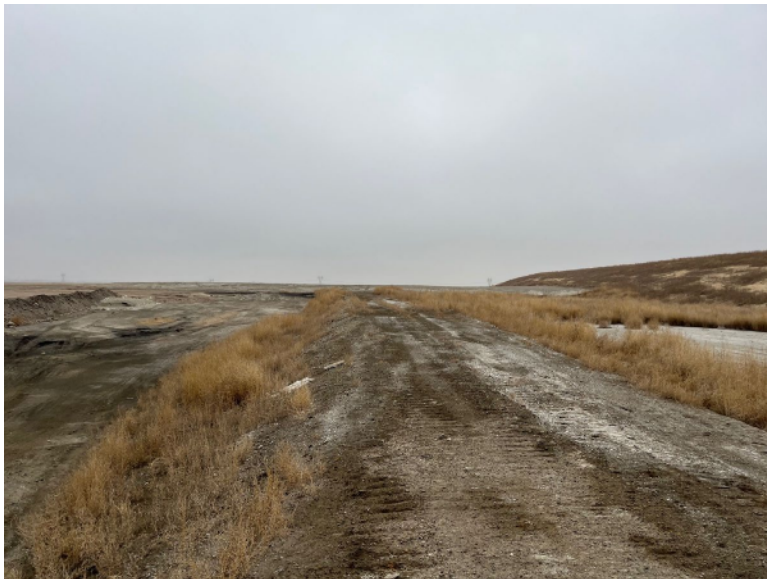
Photo 2: Phase 3A looking east. On top of waste pit.

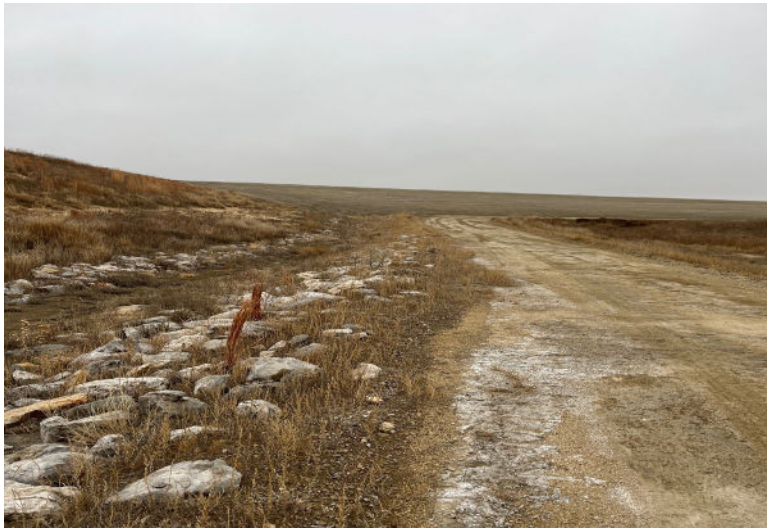
Photo 3: Contact water ditch for Landfill looking west

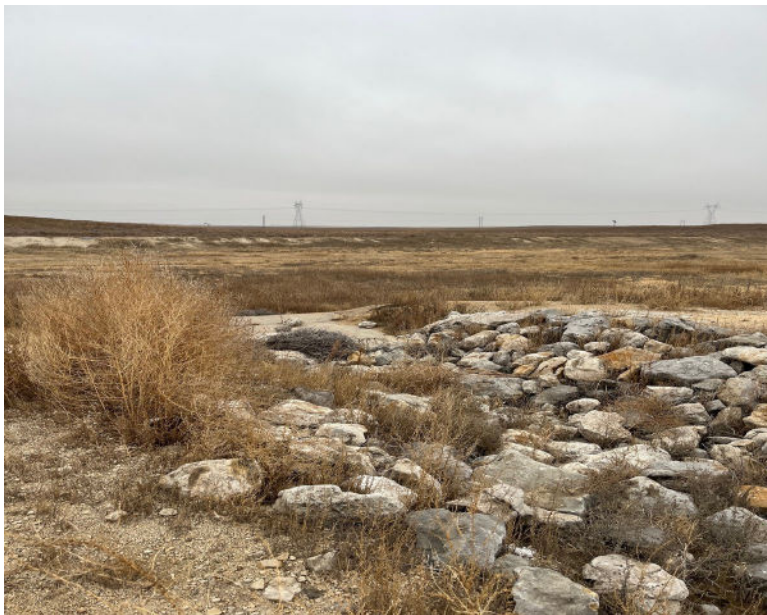
Photo 4: East end of contact water ditch to evaporation basin

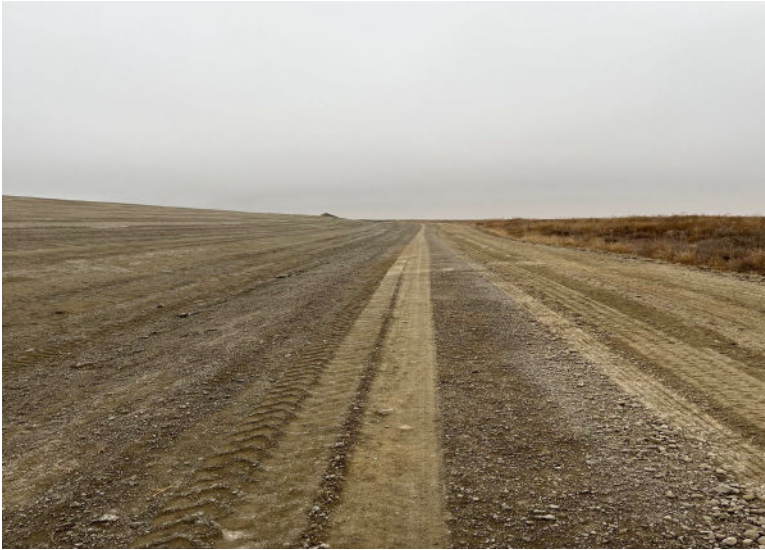
Photo 5: On access road around Phase 3A
